Name Of Dam: KINLOCH FARM DAM
Location: FAUQUIER COUNTY
Inventory Number: VA. 06109

PHASE I INSPECTION REPORT

NATIONAL DAM SAFETY PROGRAM

Kinloch Farm Dam. Inventory Number:
VA-06109. Fauquier County, Virginia.
Phase I Inspection Report.

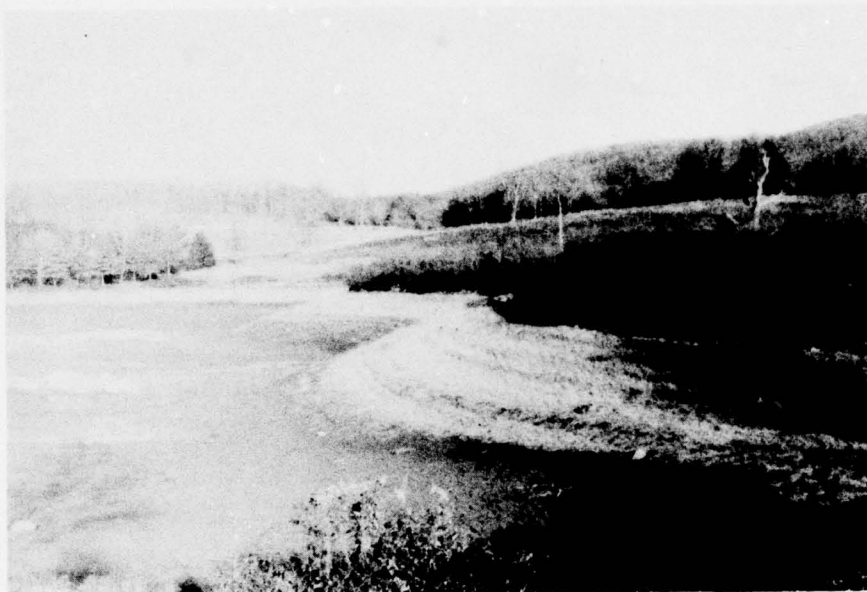
Upstream Face of Dam

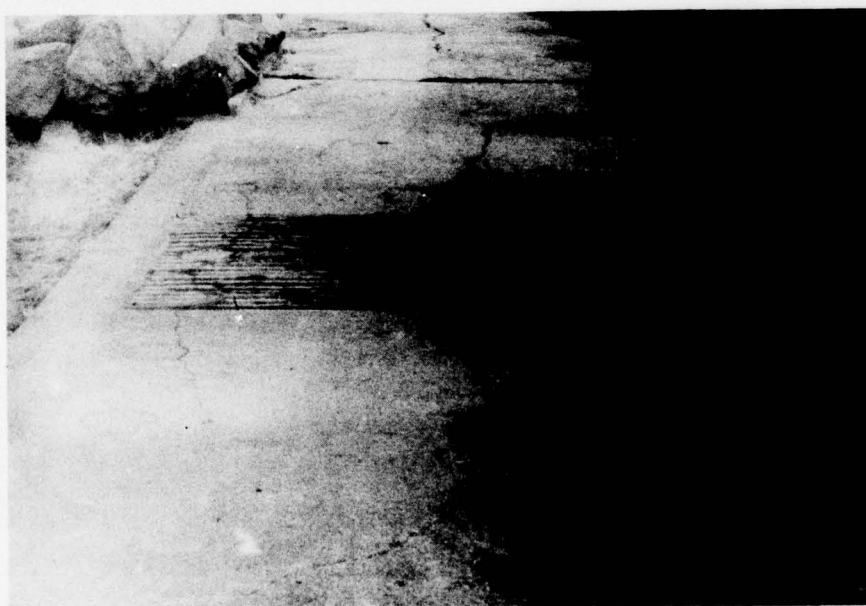
Top of Dam - Looking Northeast
Principal Spillway

7.1.2 The concrete slab on top of the dam at the primary spillway has a crack at its centerline along the axis of the dam. This can be from the erosion causing the upstream part of the slab to be unsupported. This crack could also be from settlement of the embankment. There is no evidence of any settlement in the area of this slab that would require immediate action.

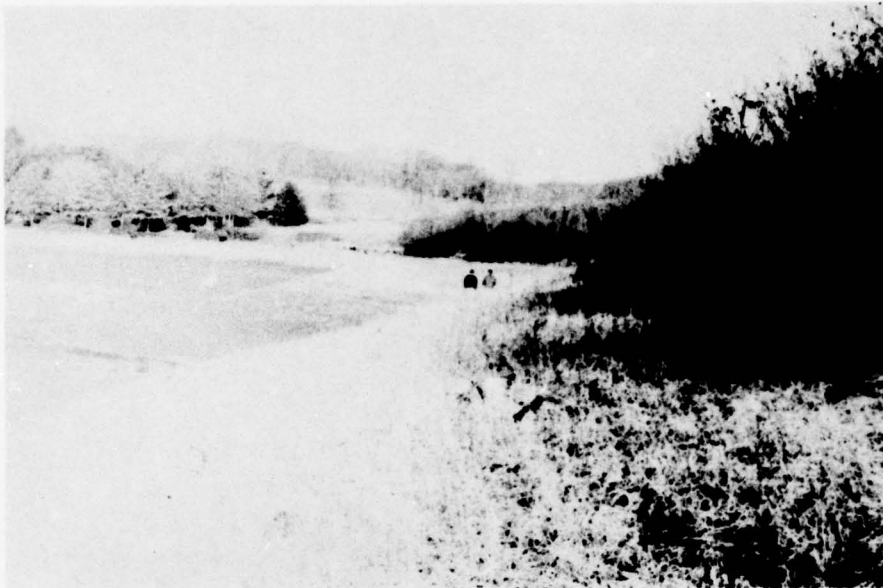
PHOTOGRAPH NO. 1
Back Face of Dam

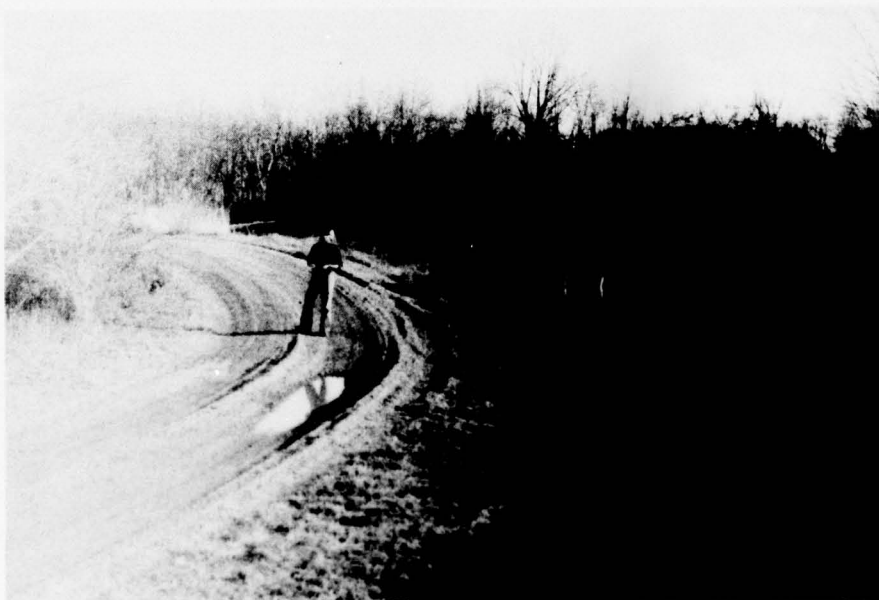
PHOTOGRAPH NO. 4
Emergency Spillway

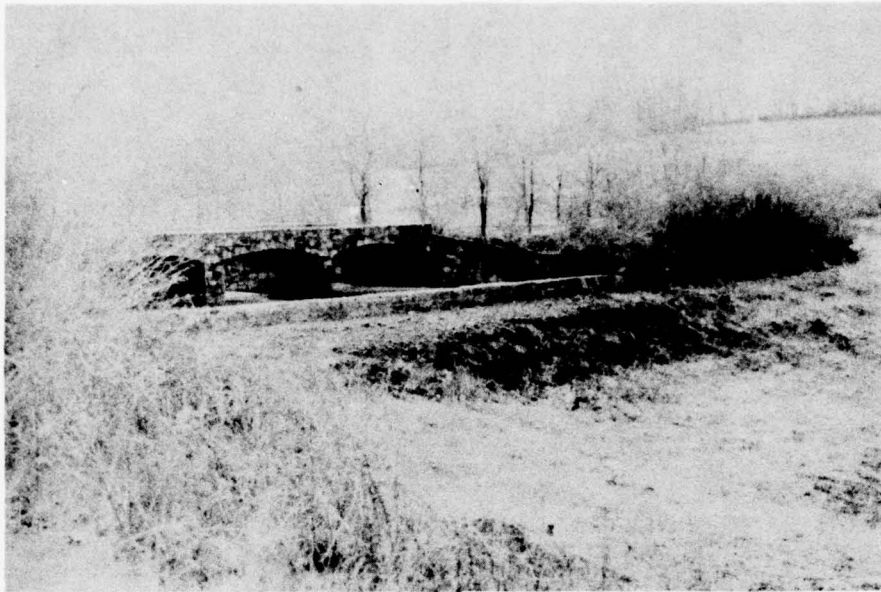
There were two massive olivine basalt outcrops along either side of the secondary spillway. There was a small seepage area observed in the secondary spillway between the two rock outcrops. According to Mr. Harmon Stevenson, the General Superintendent of Kinloch Farm, the seepage area existed prior to construction of the dam.

PHOTOGRAPH NO. 5
Secondary Spillway

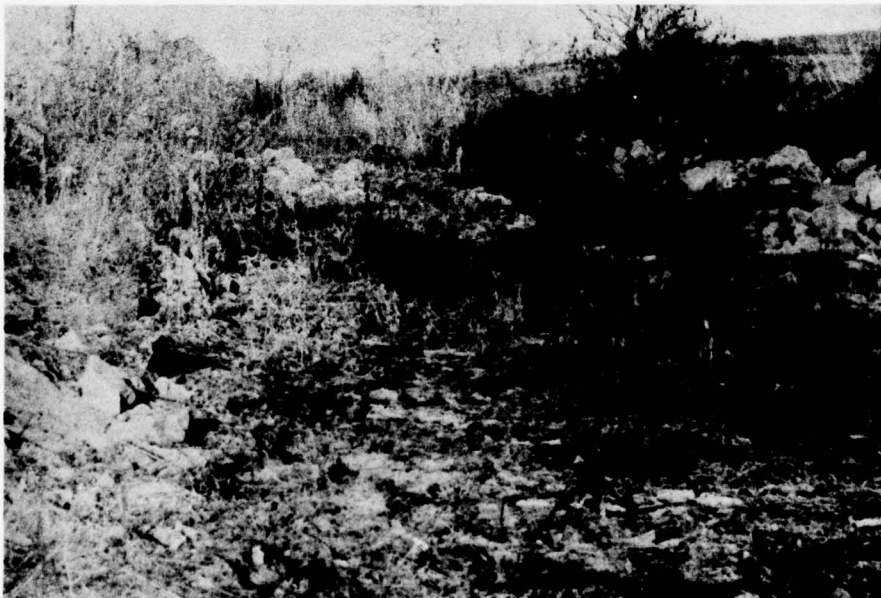
3.2 Evaluation: The visual inspection revealed no apparent problems requiring immediate attention other than the wet area of the downstream reaches of the secondary spillway channel. Since the pool was drained during the site inspection and since the seepage area reportedly existed prior to construction of the dam, it is believed that the seepage water is supplied from the hillside to the left of the dam. The two rock outcrops along either side of the spillway suggest that the basalt may form a cradle along which water from the adjacent hillside is routed. It is not felt that this seepage will adversely affect the dam, although the source of the seepage should be checked.

7.1.5 The seepage below the dam, from a rock outcrop, will not adversely affect the dam.

PHOTOGRAPH NO. 6
Downstream Channel of Secondary Spillway

7.2 Remedial Measures/Recommendations: It is recommended that geotechnical exploration and evaluation of the dam be conducted, at the owner's expense, as outlined in Section 6.3. In addition, the source of the seepage in the secondary spillway shall be determined. The combined capacity of the spillways must be increased to pass the $\frac{1}{2}$ PMF without overtopping the embankment. A warning system procedure should be established to alert residents in case of an emergency.
